# Monthly Safety Notice

December 2019

National Baromedical Services, Inc.

## Acrylic Inspection and Maintenance

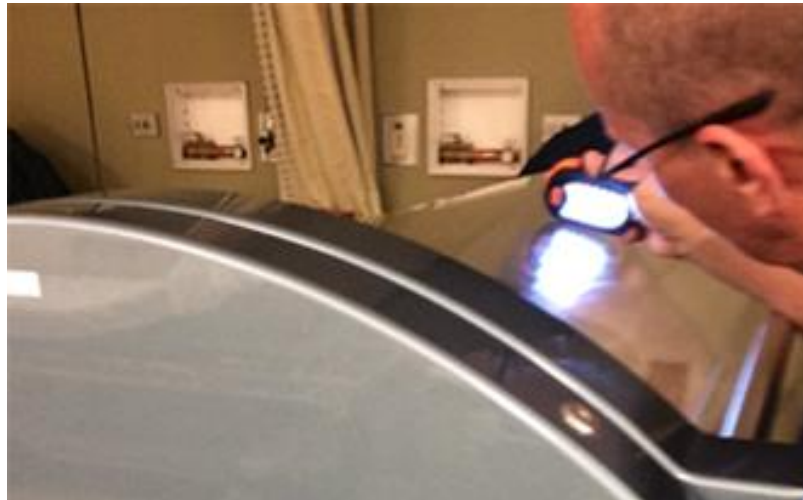
**Acrylic inspection underway**
